Materials and technologies of historical buildings - case study of two Danube fortresses

**Prof. Dr. Jonjaua Ranogajec, Faculty of Technology,
University of Novi Sad, Serbia**

**DANUBE RECTOR`S CONFERENCE
4-6 February 2010**

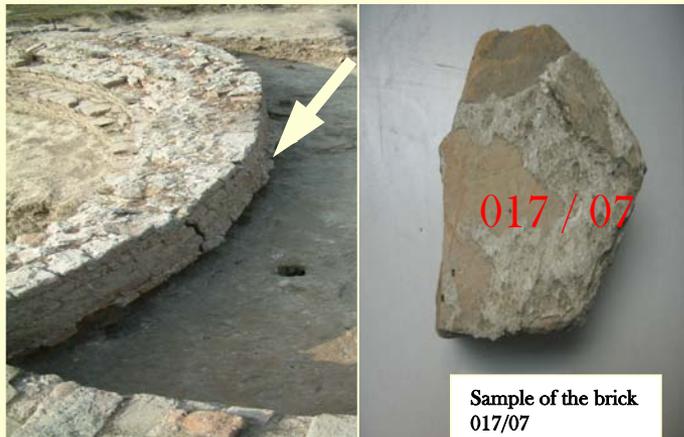
Sample of the brick
017/07

● 1. Brick 017/07 is a ceramic system based on quartz, feldspar, calcite and diopside. It was fired in reduced atmosphere, below 600. The interval of dominant pore radius is between 0.5 and 1 mm, with a vol. pores of 18%. The product as a hand-modeled element, possesses a low water absorbing index (18.74 mass.%).

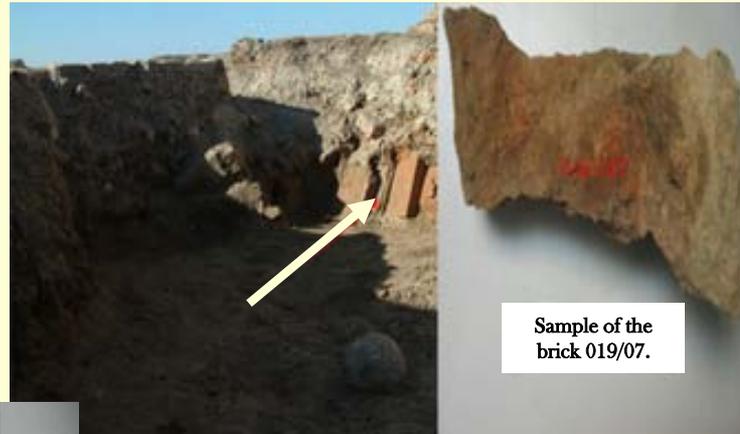
Sample of the
brick 019/07.

● 2. Brick 019/07 consists of newly formed crystal phases: mellilite (Ca, Na/K)(Mg,Al,Fe)(Si₂O₇) and hematite - Fe₂O₃, as well as mineral components as quartz, feldspar and mica originated from the raw material. It is a system fired below 800 °C mostly in oxidative atmosphere. The interval of dominant pore radius is identical to brick sample 017/07.

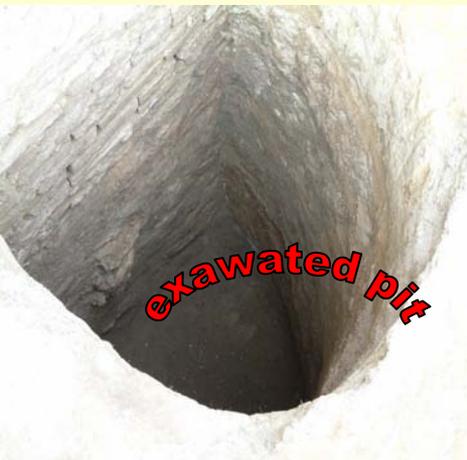
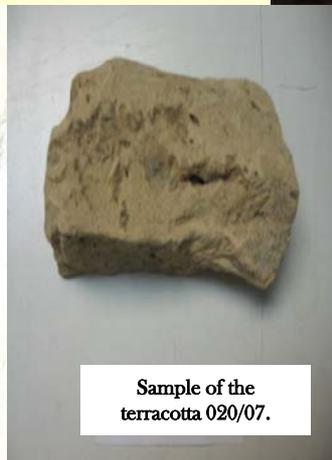
Sample of the
terracotta 020/07.

- *3. Terracotta 020/07 is a creamy-white ceramic material (mass.% Fe₂O₃ in traces, high mas.% CaO- 15.47), which consists of crystal modifications such as mellilite, diopside and quartz, feldspar and calcite. High temperature of firing with usage of organic material (probably straw) is the characteristic of this system.*
 - *4. Clay Roof tile 023/07 is an orange-red ceramic material (4.80 mass.% Fe₂O₃), which consists of quartz, feldspar, calcite and mica as the origin materials and newly formed phases – hematite.*
 - *The data of mineral composition, original firing temperature and the textural characteristics of the historical materials are an essential background for the future production of new specific materials for the restoration of medieval fortress such as Bač*
-

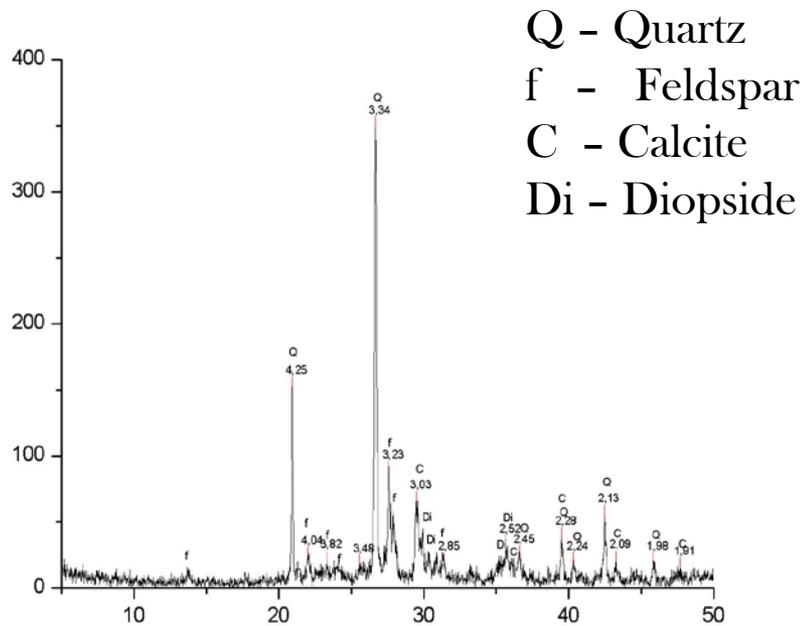
Fig. XRD pattern of the brick sample

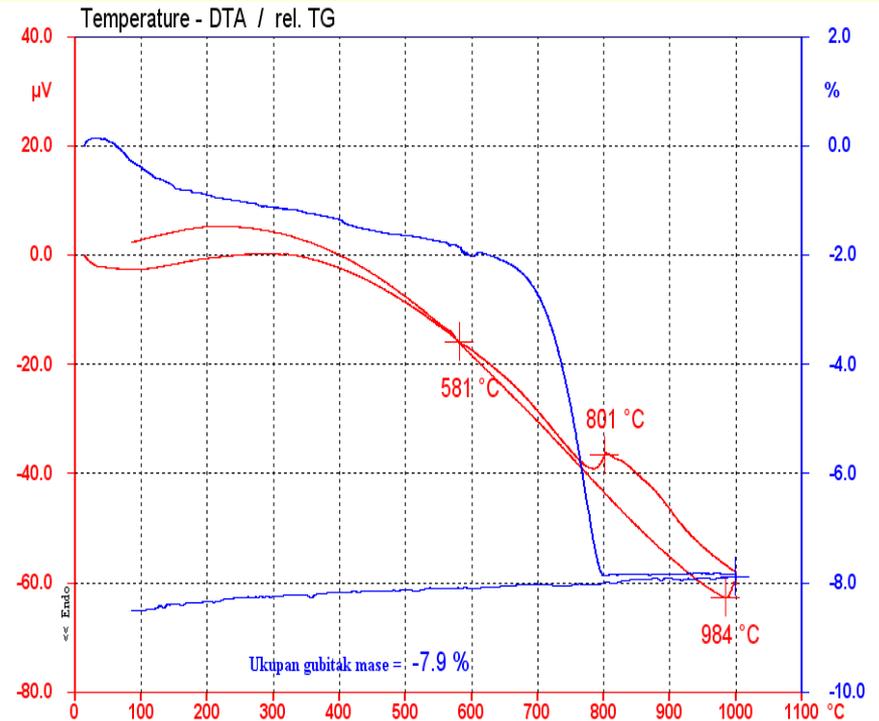
Fig. DTA / TG analysis of brick sample

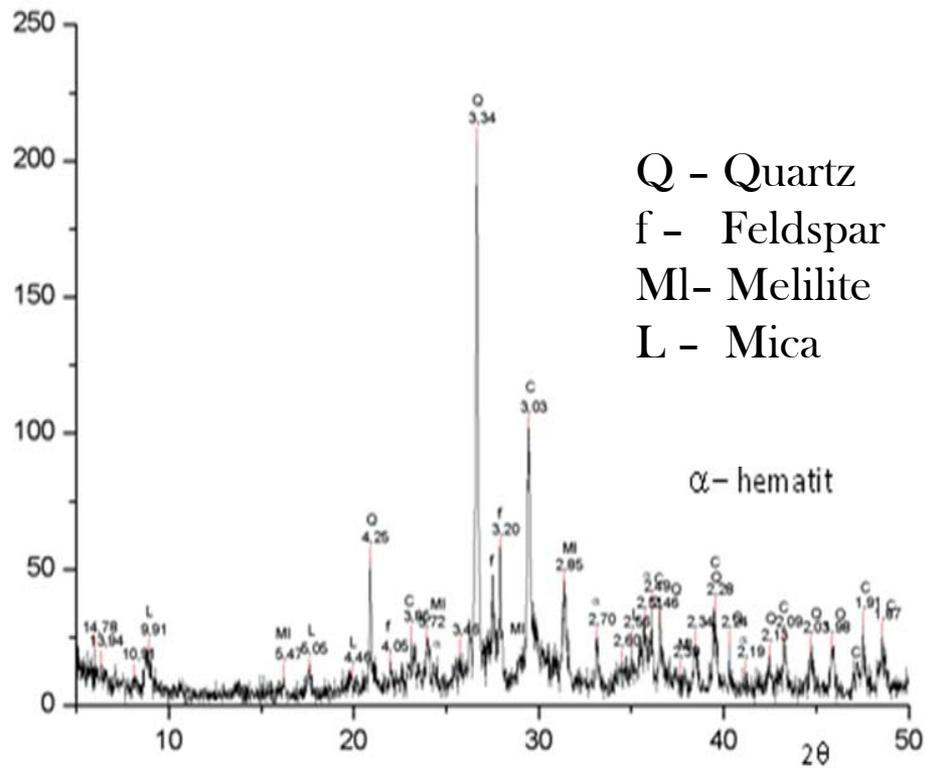
Fig. XRD pattern of the brick sample

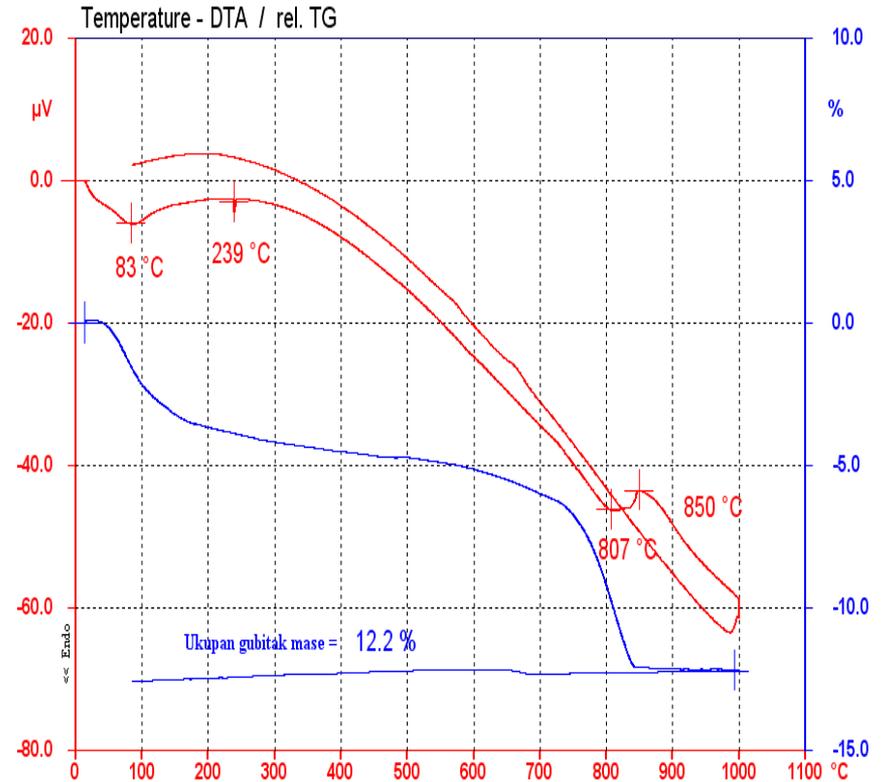
Fig. DTA/TG analysis of the brick sample

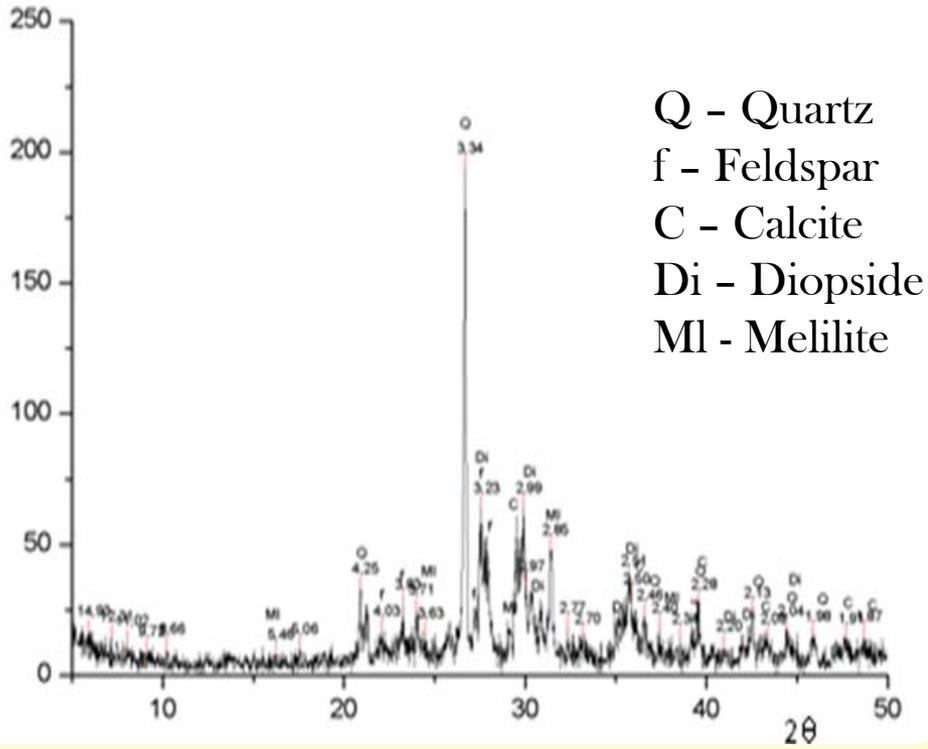
Fig. XRD pattern for the sample of terracotta

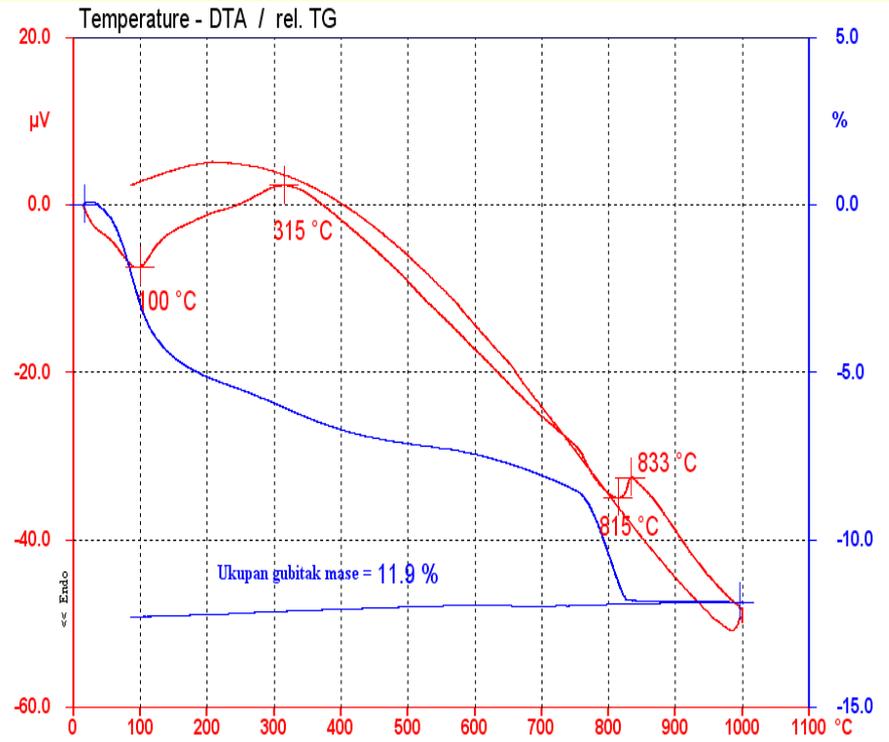
Fig. DTA/TG analysis for the terracotta sample

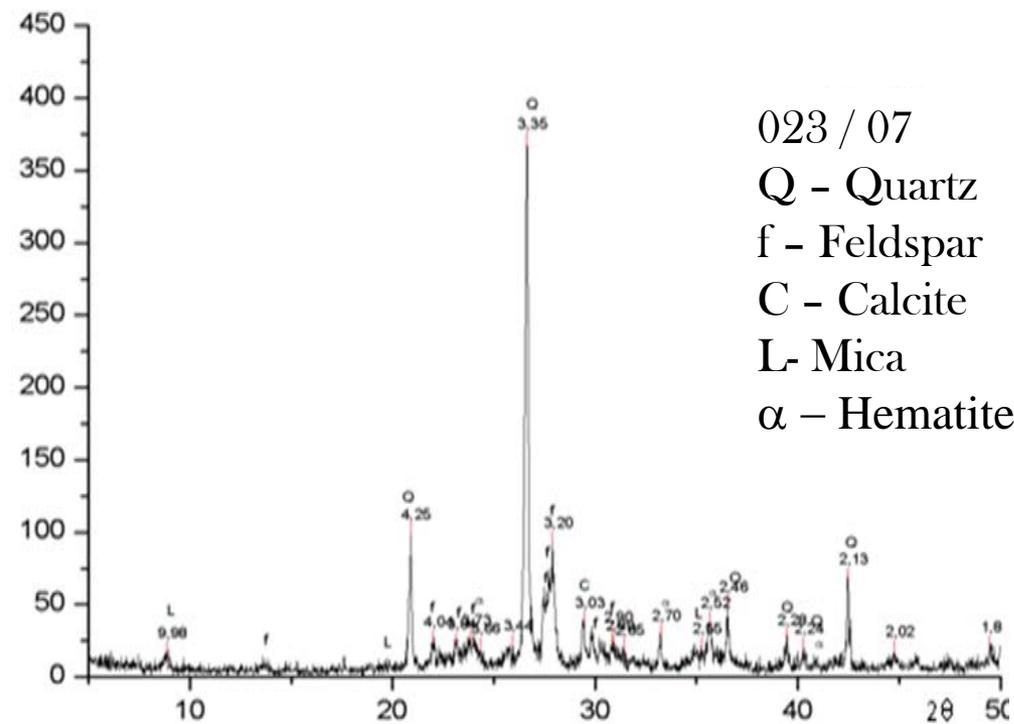
Fig. XRD pattern for the sample of clay roof tile

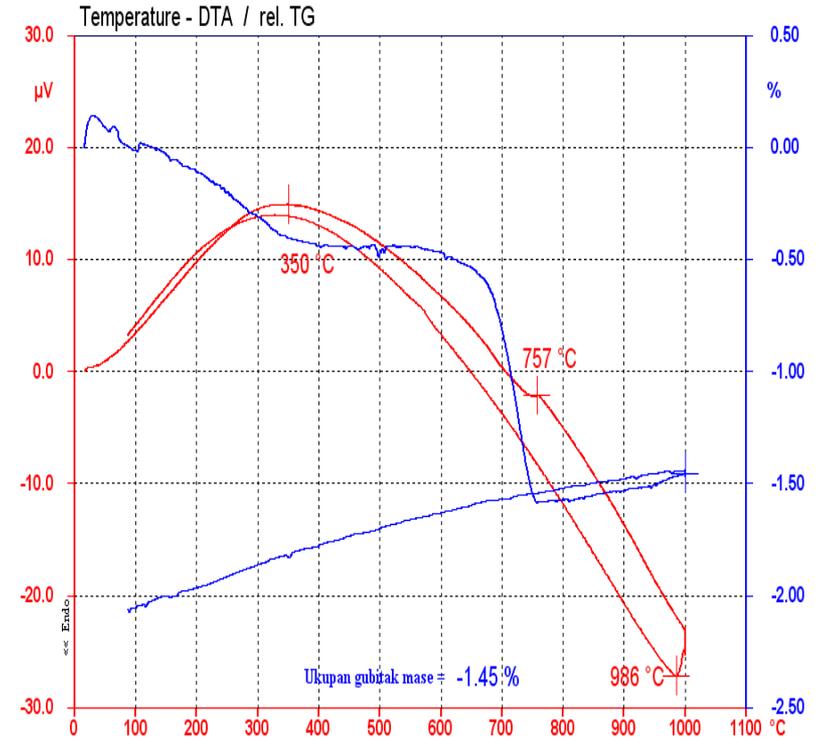
Fig. DTA/TG analysis graphical view for clay roof tile sample

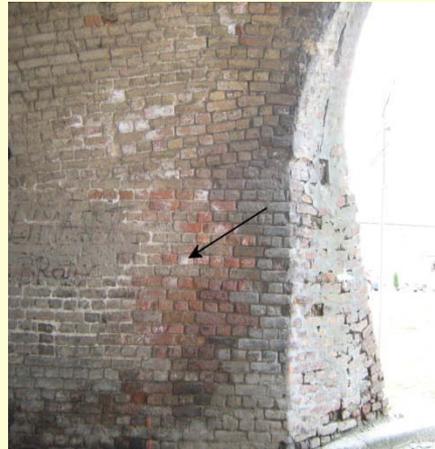
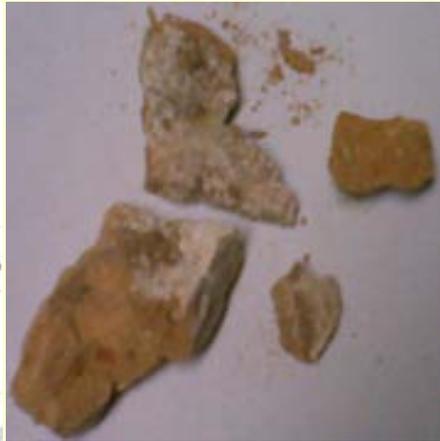
Image of the brick PTT 4, sampling hight 1.80 m

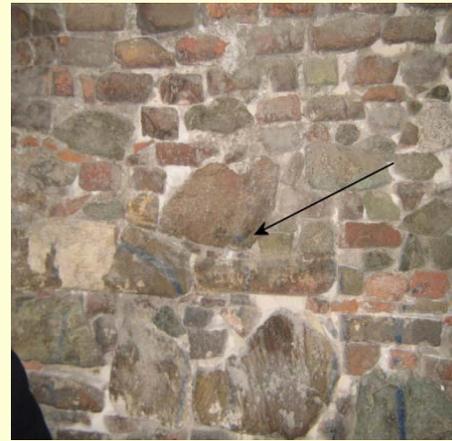
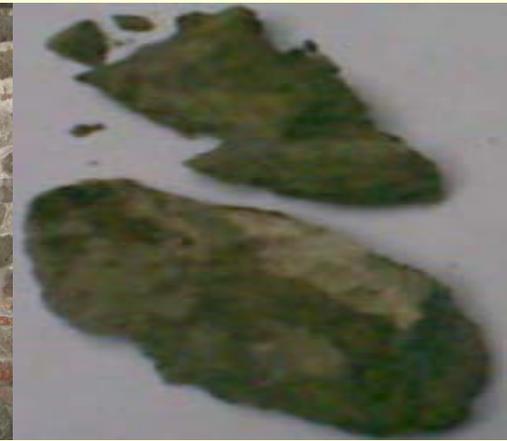
Image of the stone PTT 10, sampling hight 1.70 m

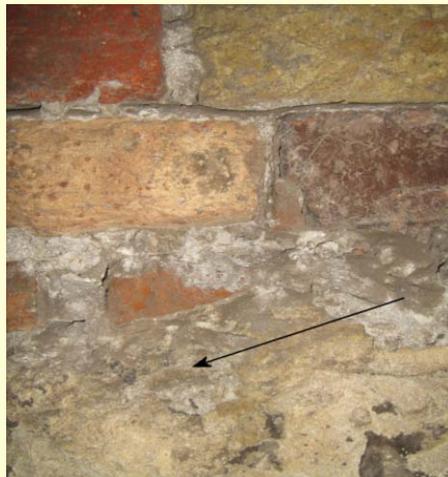
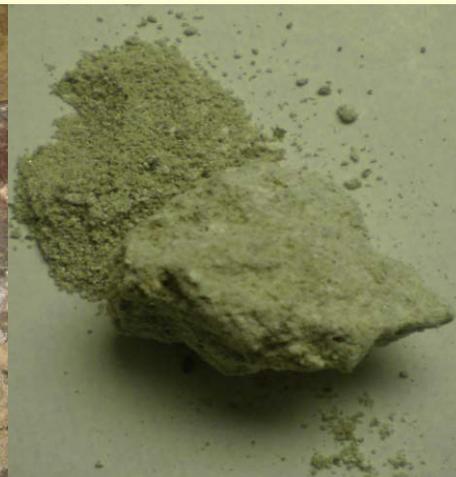
Image of the mortar PTT 8, sampling hight 1 m

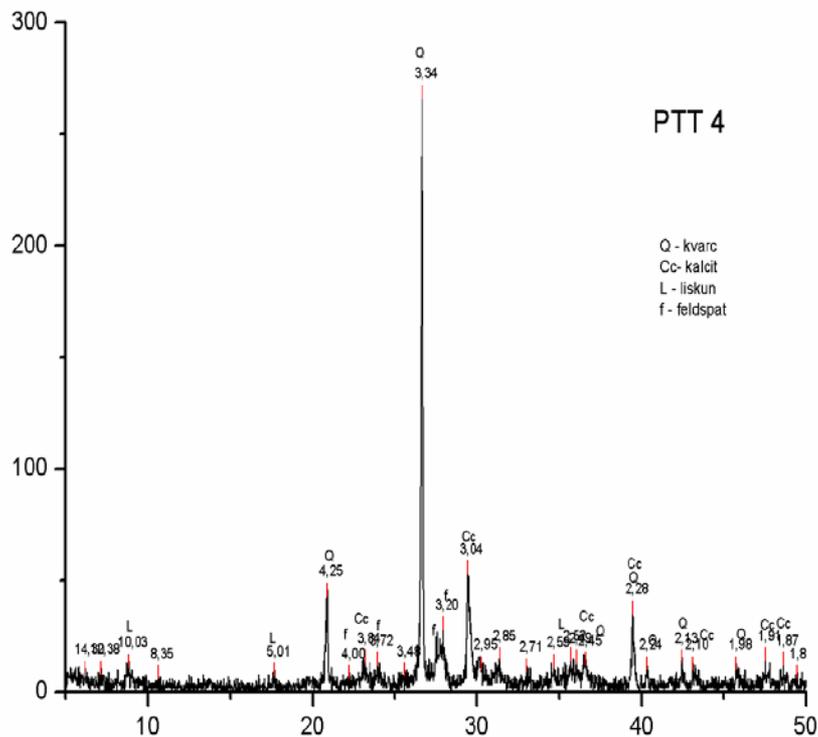
XRD pattern for the sample of the brick sample PTT 4

1. The brick sample PTT 4 is a ceramic system based on quartz, feldspar and mica. Firing temperature of the brick sample (900 °C) was determined based on dilatometric analysis. This sample has high value of water absorption and high share of open pores (40 %).
 2. The stone sample PTT 10 is a metamorphic rock material with the presence of the carbonates. The surface of sample stone is covered with a layer black patina. Low water absorption with a few open pores (20 %) is identified.
 3. The mortar sample PTT 8 - inhomogeneous structure with the presence of white grain (carbonates). Based on the structure characterisation the presence of lime mortar is confirmed.
-

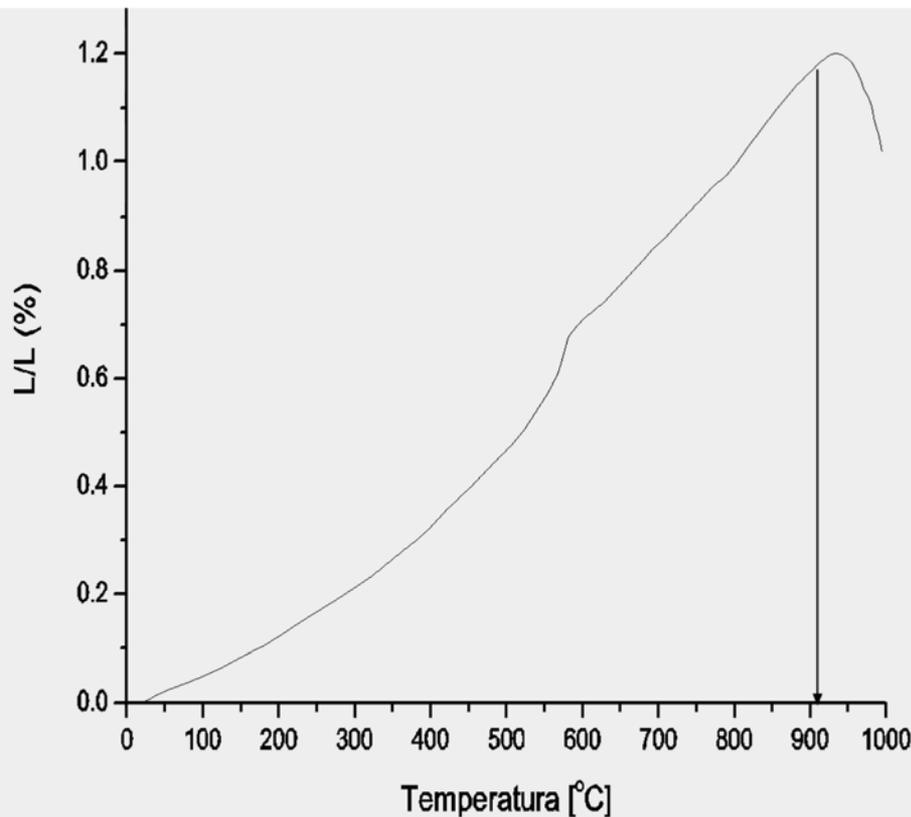
Image of Dilatometric analysis of the brick sample PTT 4

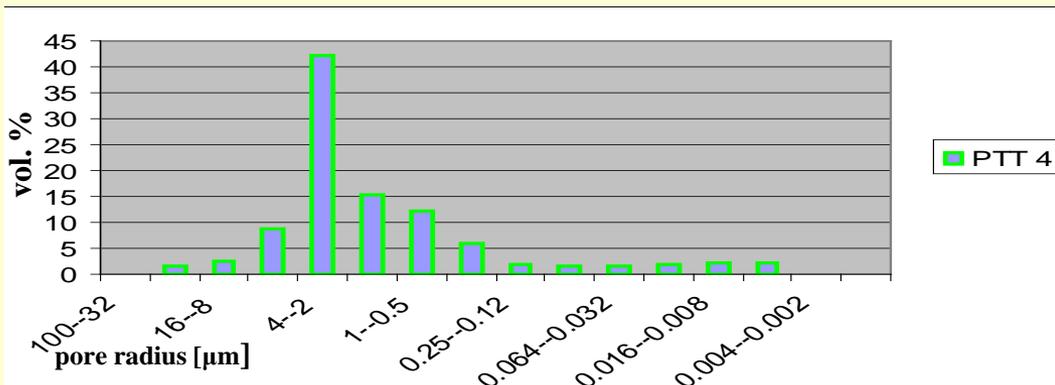
❖ Mercury porosimetry results

Sample	Cummulative volume pore [mm ³ /g]	Total pores [%]
PTT 4	261.30	38.93

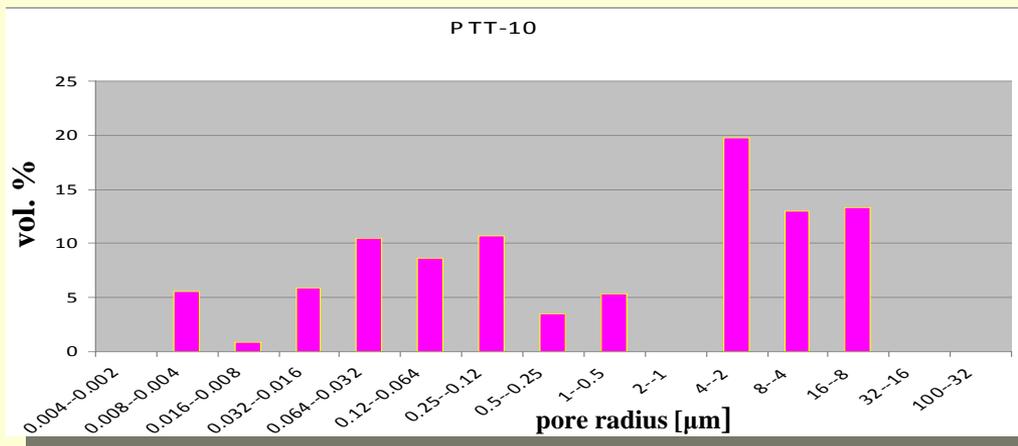
❖ Mercury porosimetry results

Sample	Cummulative volume pore [mm ³ /g]	Total pores [%]
PTT 10	19.82	4.14

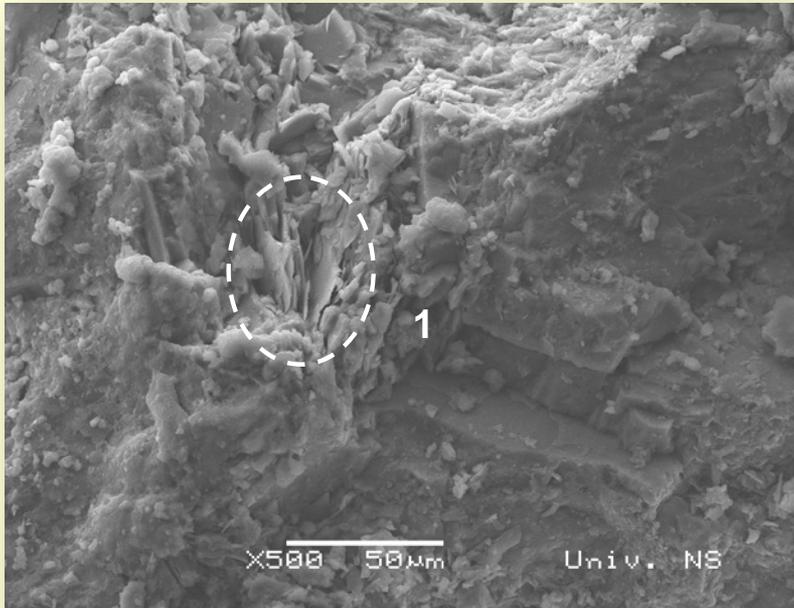
SEM micrograph of the stone sample PTT 10, x500

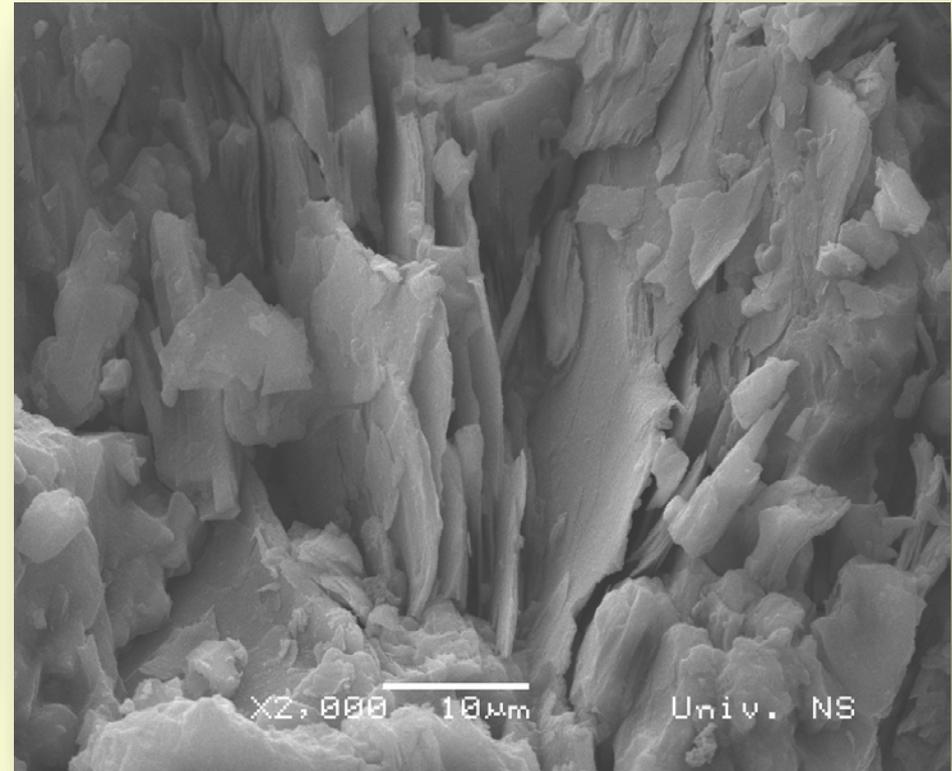
SEM micrograph of the stone sample PTT 10, x2000

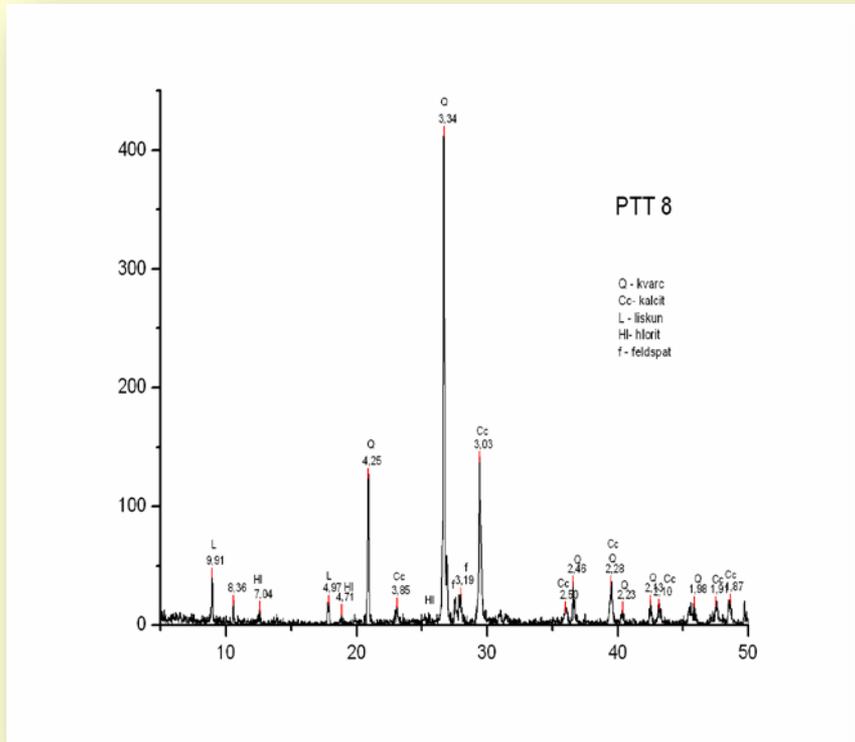
XRD pattern of the mortar sample PTT 8

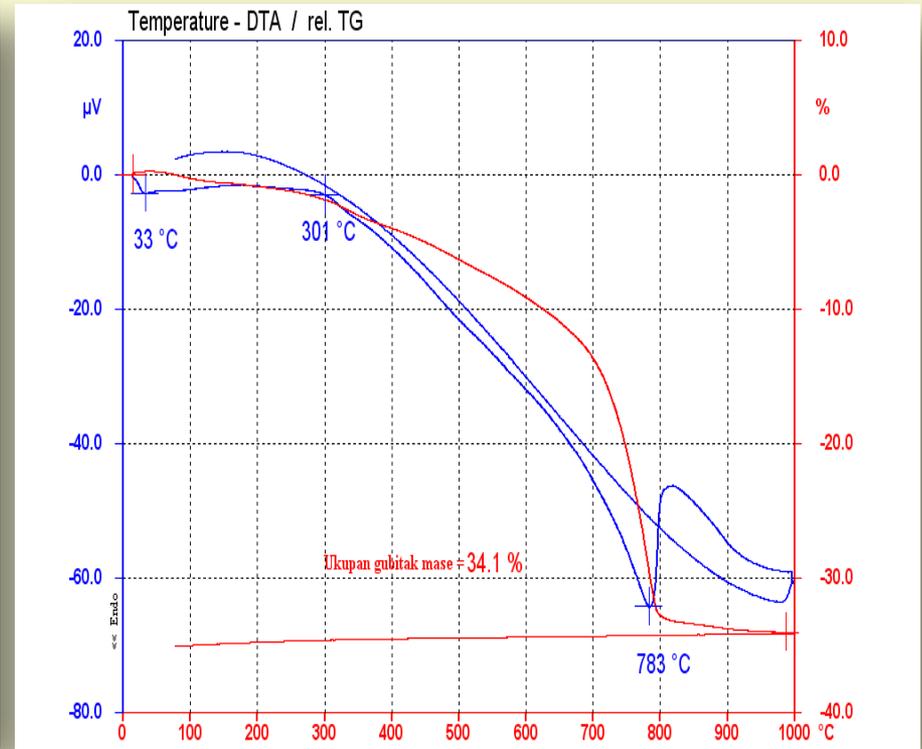
DTA/TG analysis graphical view of the mortar sample PTT 8

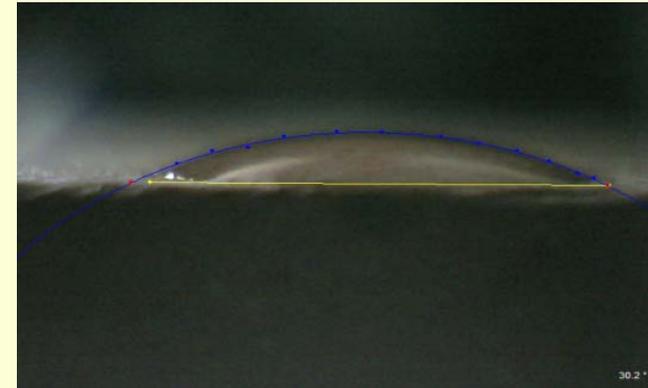
Samples with M coatings- show very good self-cleaning (small water contact angle values) and photocatalytic properties (rhodamin B test and FTIR test) in relation to commercial coatings.

Contact angle measurements for tiles coated with M coating

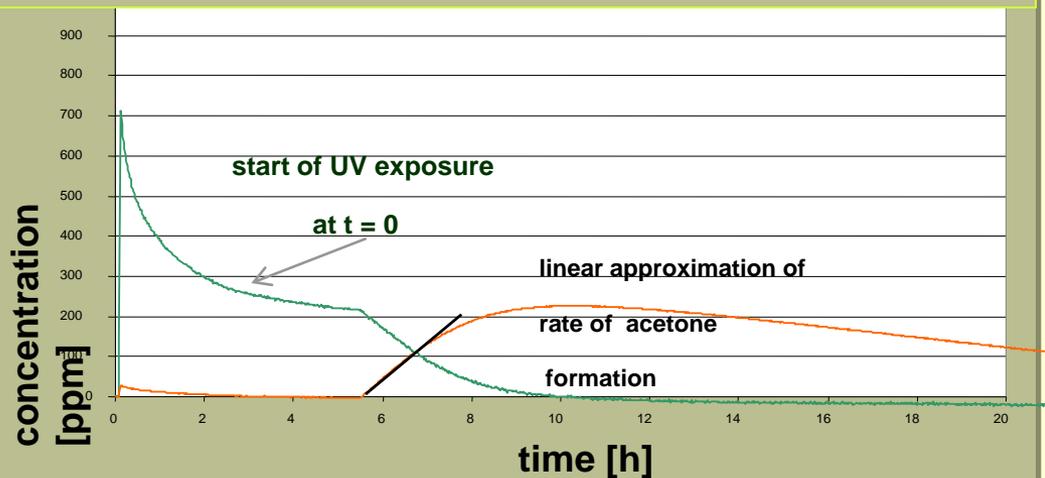
The course of photocatalytic degradation of iso-propanol

Rate of acetone formation

Conc. acetone (ppm/h) = 181.5

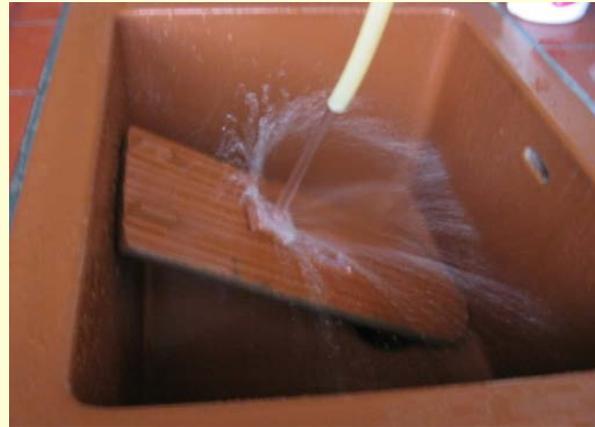
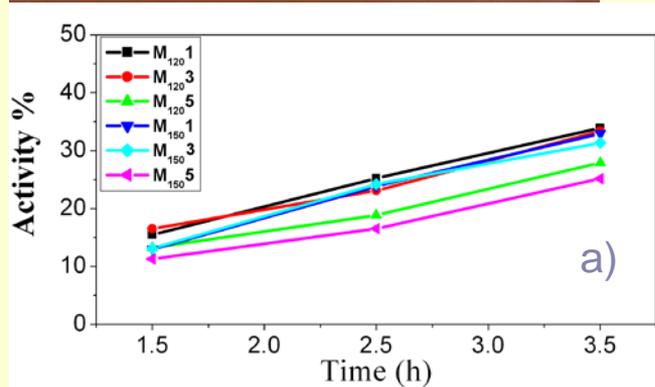
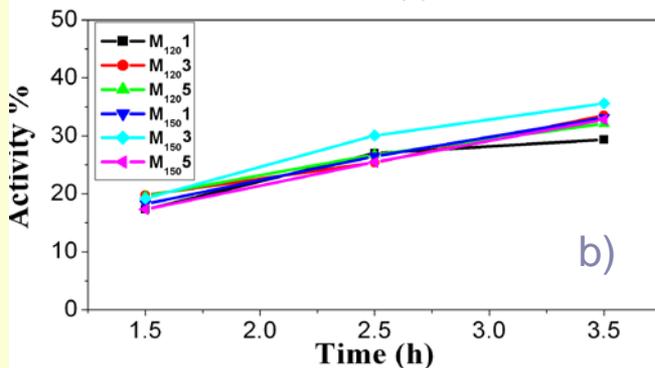
Photocatalytic activity-Degradation of water solution of rhodamin B

- Photocatalytic activity of the coated tiles was examined before and after sample rinsing procedure with water (flow rate was 0.136 liters per second during 30 min. under 45° angle)

- Photocatalytic activity of the tiles coated with M films, before (a) and after (b) water rinsing

Samples with M coatings showed great resistance to water rinsing procedure which was manifested as small or negligible decreasing of the photocatalytic activity values.

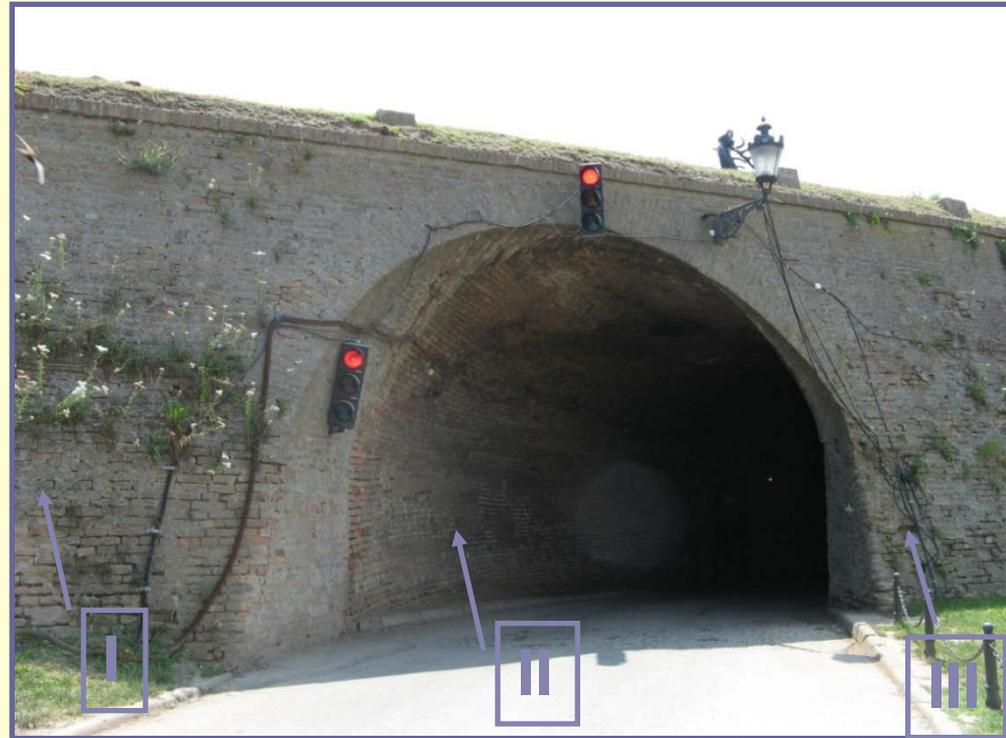
- 3 small areas (2 outside: areas I and III and 1 inside the tunnel: area II)
- already restored tunnel surface was coated with the laboratory prepared TiO₂ suspension
- efficiency of this treatment was evaluated through physical investigation and surface observation

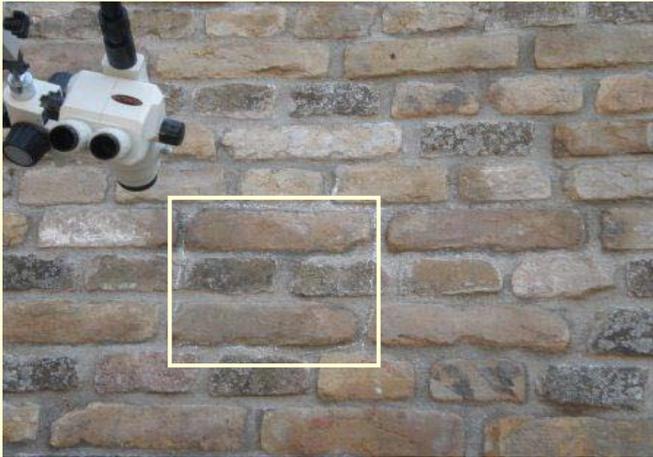
Before application of the TiO_2 coating

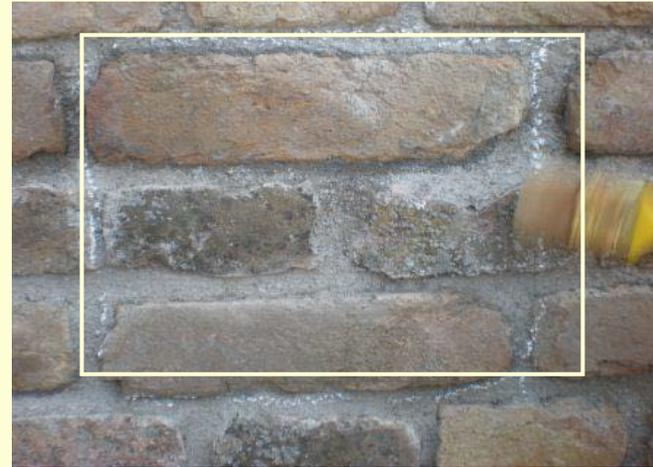
Immediately after application of the TiO_2 coating

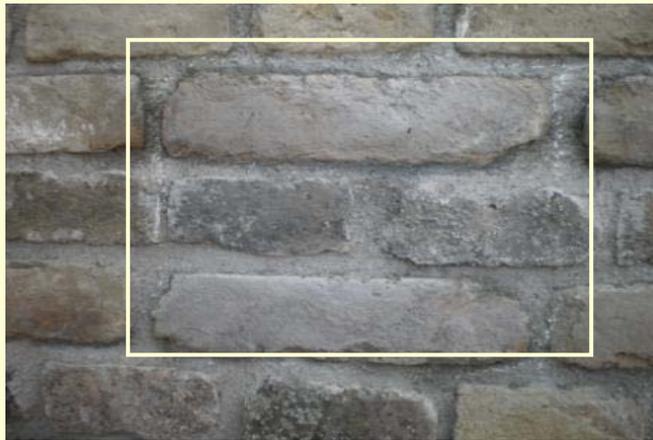
1 week after application of the TiO_2 coating

There are no visible changes

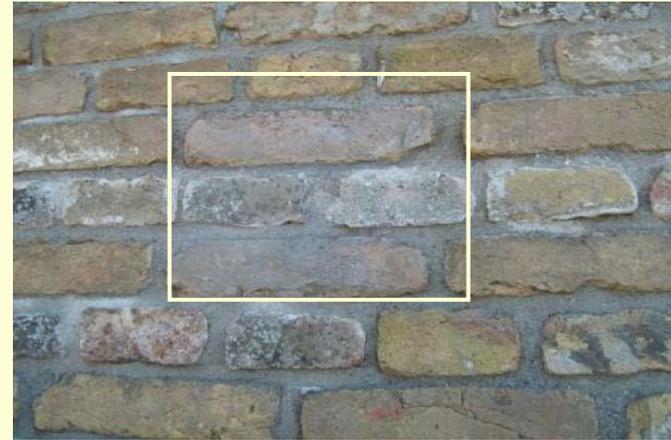
4 weeks after application of the TiO_2 coating

- Applied coating was stable after four weeks of adverse environmental conditions.
 - In the area of the inside wall of the tunnel, no visible changes connected with the photocatalytic effect (self-cleaning) were detected.
 - In the areas of the outside walls of the tunnel, changes connected with the photocatalytic effect (self-cleaning) were detected → lichens were drying out.

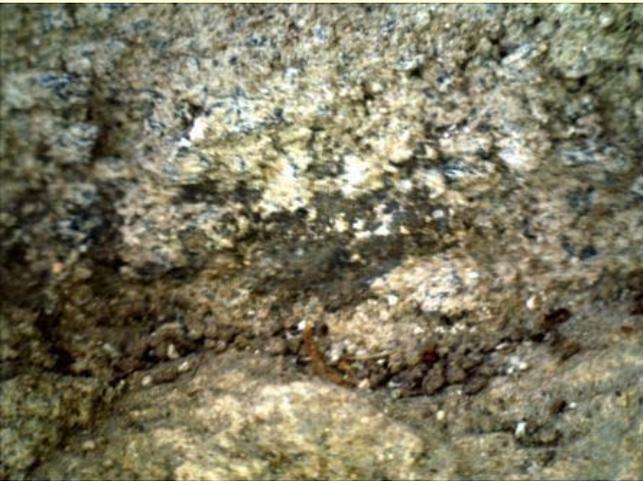
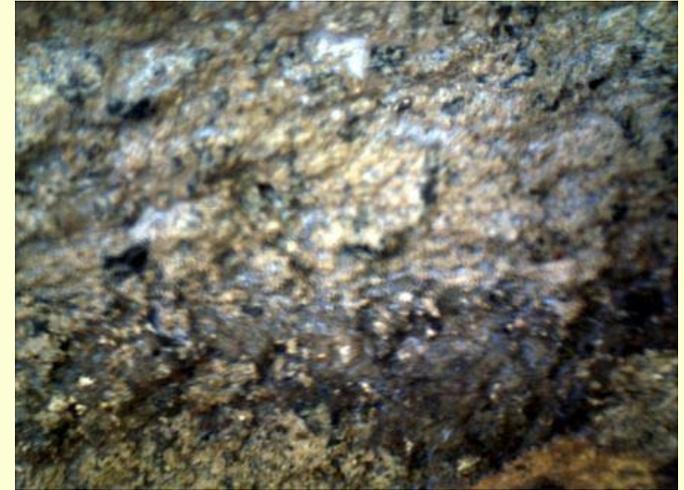
Optical microscopy of the old mortar sample a) *Before application of the coating; b) immediately after application of the coating*

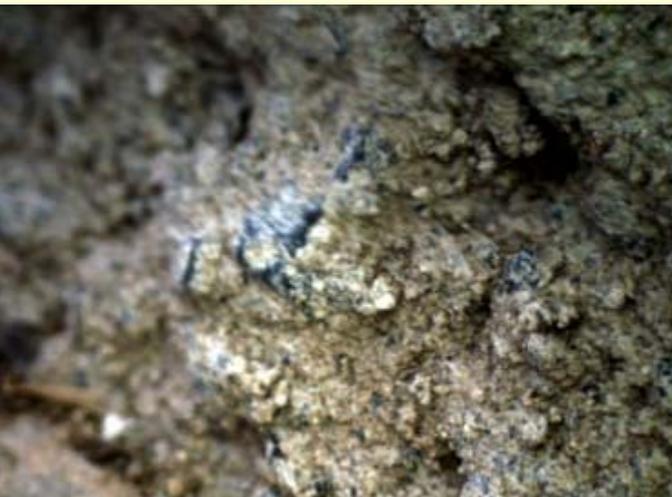
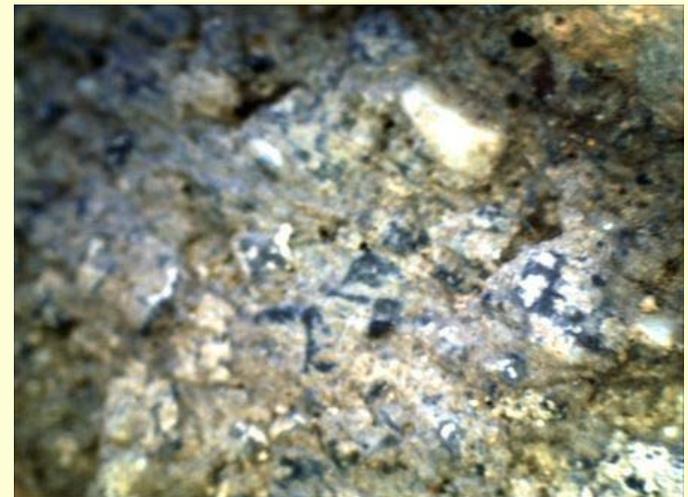
Optical microscopy of the old mortar sample a) *1 week after application of the coating; b) 4 weeks after application of the coating*

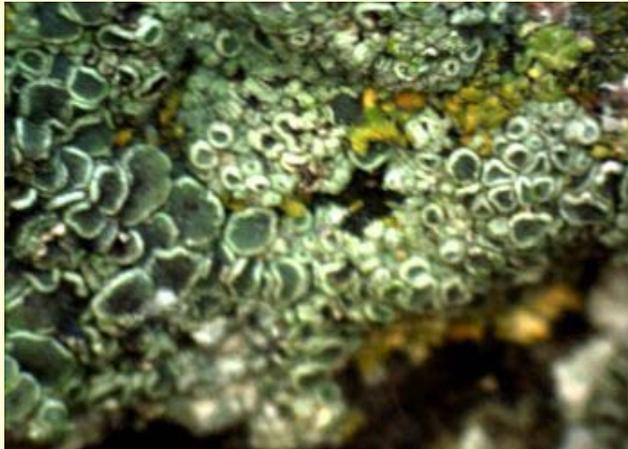
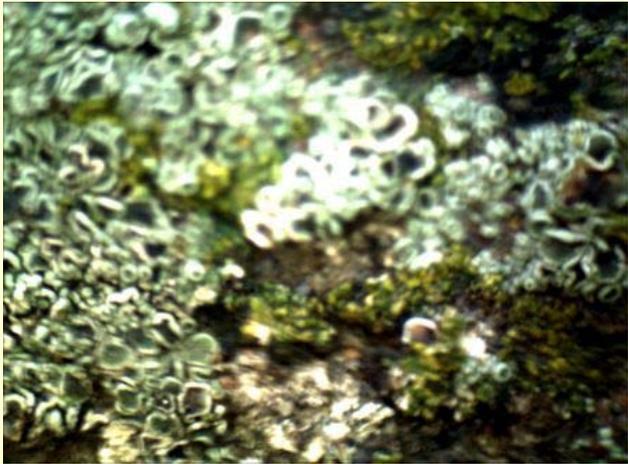
Optical microscopy of the old mortar a) *Before application of the M coating; b) immediately after application of the M coating*

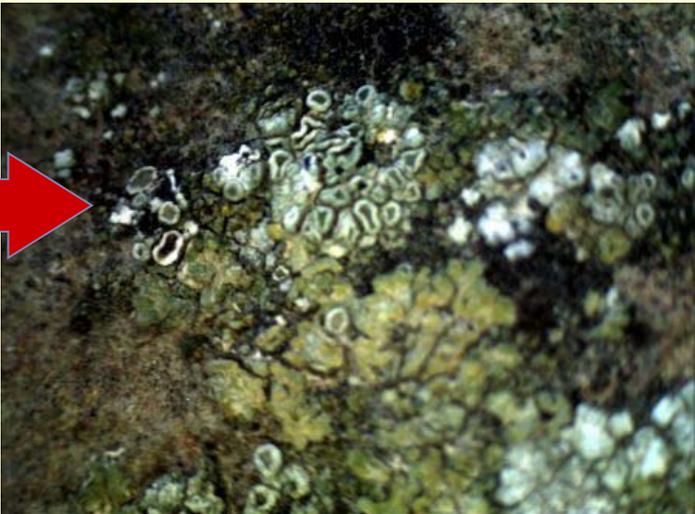
Fig. Optical microscopy of the old brick a) *1 week after application of the M coating; b) 4 weeks after application of the M coating*
